## **New Construction Projects Nearly Complete at Craig Brook National Fish Hatchery**

### **New Penobscot Broodstock Holding pools**

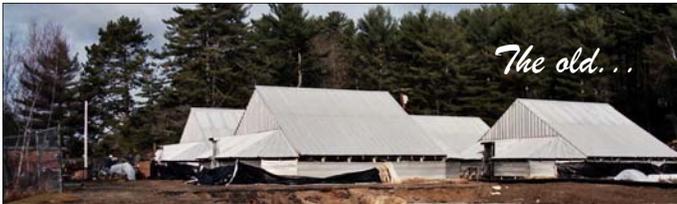
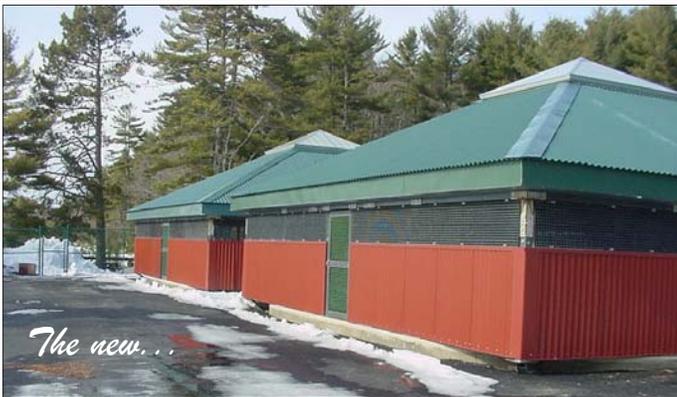
While awaiting the arrival of the spawning season, the fish will be well-protected in the newly covered pools pictured above. The designers used the same concrete pools that have been in place since the 1960s— they're still in excellent shape, but now have a new fiberglass coating. The pools also have new roof coverings made completely of fiberglass— even the I-beams! They're just as strong as steel, but have a much longer lifespan.

The four covered pools (only two are pictured) effectively keep away predators, and the fiberglass pool coating is far easier on the fish— it all but eliminates skin abrasions and nose bump injuries while they're here.

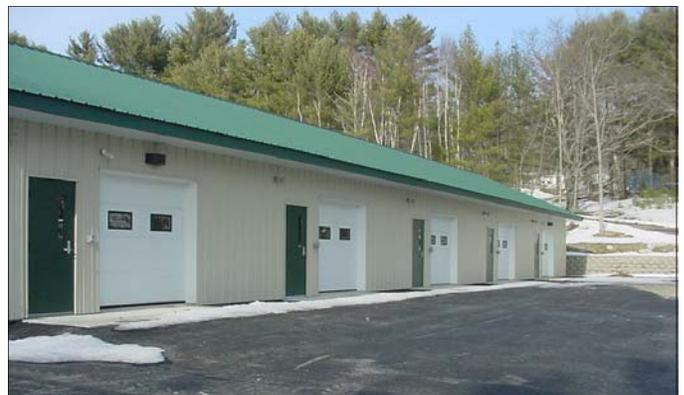
### **The new Penobscot Disease Screening Building**

An essential part of maintaining fish in a hatchery is fish health. This new building is Craig Brook's Penobscot Disease Screening Building. Its five bays allow for fish coming in from the river to be screened for diseases they may have contracted in the wild. Blood samples are taken from every fish and sent to the U. S. Fish & Wildlife Service Fish Health Unit located in Lamar, Pennsylvania for analysis.

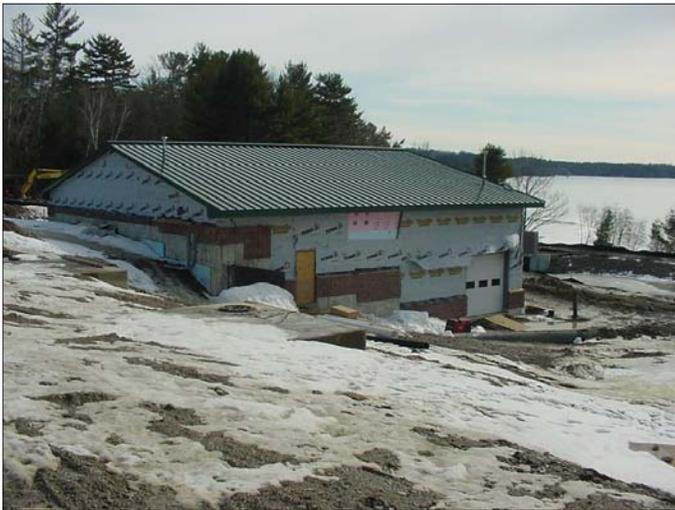
## The New Fish Waste Treatment Plant

The new Fish Waste Treatment Plant, shown above nearing completion, is a long-awaited addition to the Craig Brook facility. It's designed to remove solids from the waste water, reduce phosphorus content and disinfect with the use of ultraviolet light exposure.

The first stage of treatment involves the use of a five-part micro screen system to remove solids. The waste water is then mixed with alum (aluminum sulfate) and a polymer which produces a precipitate of the remaining solids. The micro screening process is then repeated, allowing the additional solids to settle out. The solids are collected in a storage tank which is emptied about every six months.

The waste water is finally exposed to ultraviolet light which kills bacteria, and then leaves the plant, flowing into a large pool and eventually into Alamoosook Lake. The installation of the plant will improve the quality of the hatchery's effluent considerably. **FCB**

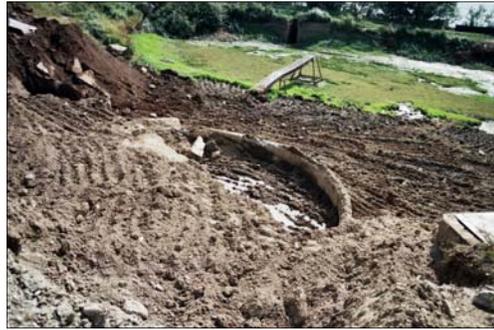
**Pools used at Craig Brook NFH ca. 1930-1953**

During the excavation for the new waste water treatment plant in 2005, heavy equipment struck a very hard object just above Alamoosook Lake. As more dirt was removed, the object turned out to be two large round concrete fish holding pools built probably in the 1930s and used until they were covered with the construction of the raceways in the 1950s. The raceways served the facility from that time until the new hatchery was built in 1998-2000.

The two 18-foot-diameter pools were located just above the two settling ponds which prior to the new waste water plant's completion served to treat the facility's waste water by bacterial action.

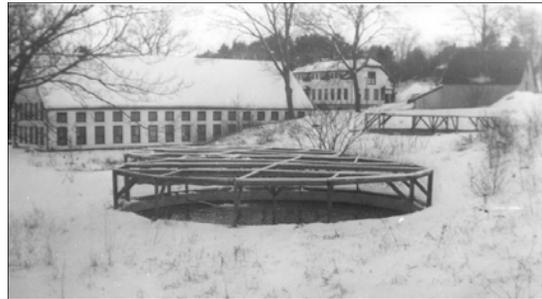
To determine the age of the pools, we use two methods— researching the Atkins Archives for construction records, and second by using dating clues included in photographs. In the photo above the two pools uncovered during the recent construction are seen close together, and a third a short distance away. On the left is the “Lower Hatchery”, which was heavily damaged in a flood after the Craig Pond dam broke in March 1953. It was subsequently demolished. The “Upper Hatchery”, in the distant background, was constructed in 1906 and razed in 1957.

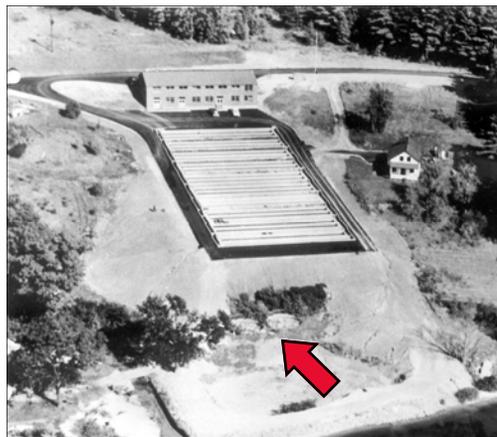
The old pools appear again in the picture above, taken ca. 1954, just after the construction of the raceways. The red arrow shows the two old pools still in place, and just before being covered for construction of the two settling ponds. **FCB**

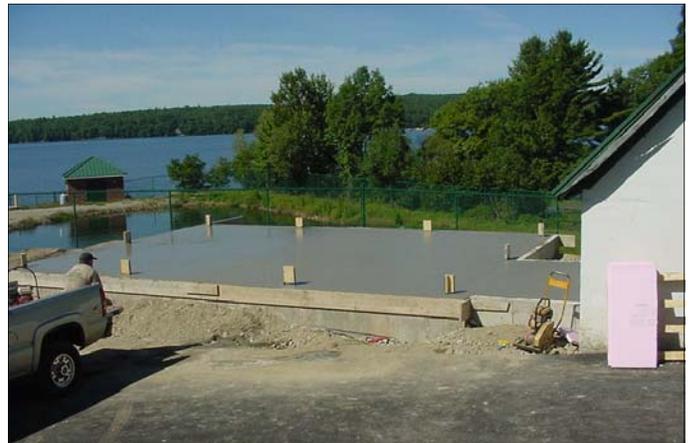
The Friends of Craig Brook have been very busy fund raising and making preparations for the construction of a new addition to the Atlantic Salmon Heritage Museum at Craig Brook NFH. Pictured above is the newly completed foundation and slab which will accommodate the 32 x 24-foot addition to the existing museum seen at far right. The new addition will increase the display capacity of the Heritage Museum by well over a hundred percent.
